⑥ National Dam Inspection Program.  
Bryant Pond Dam

BRYANT POND DAM

NDI ~~to~~ Number PA-00544  
DER ID Number 40-11

PHASE I INSPECTION REPORT

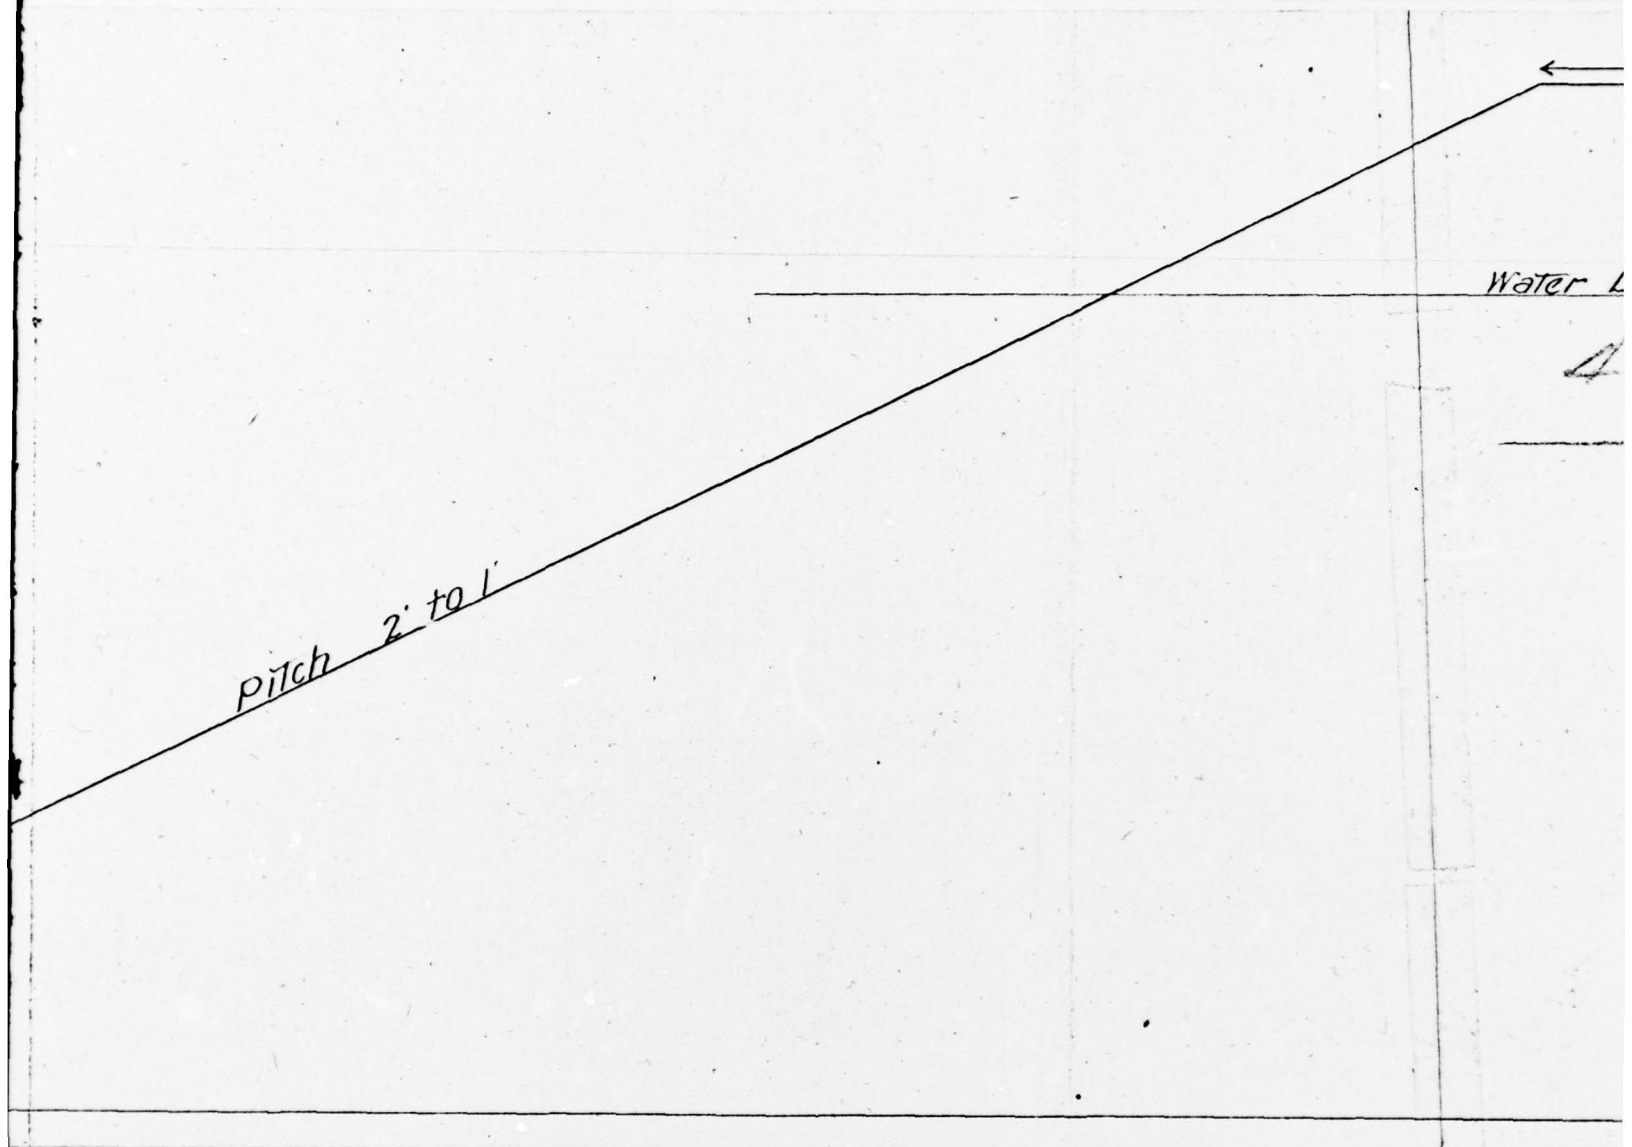
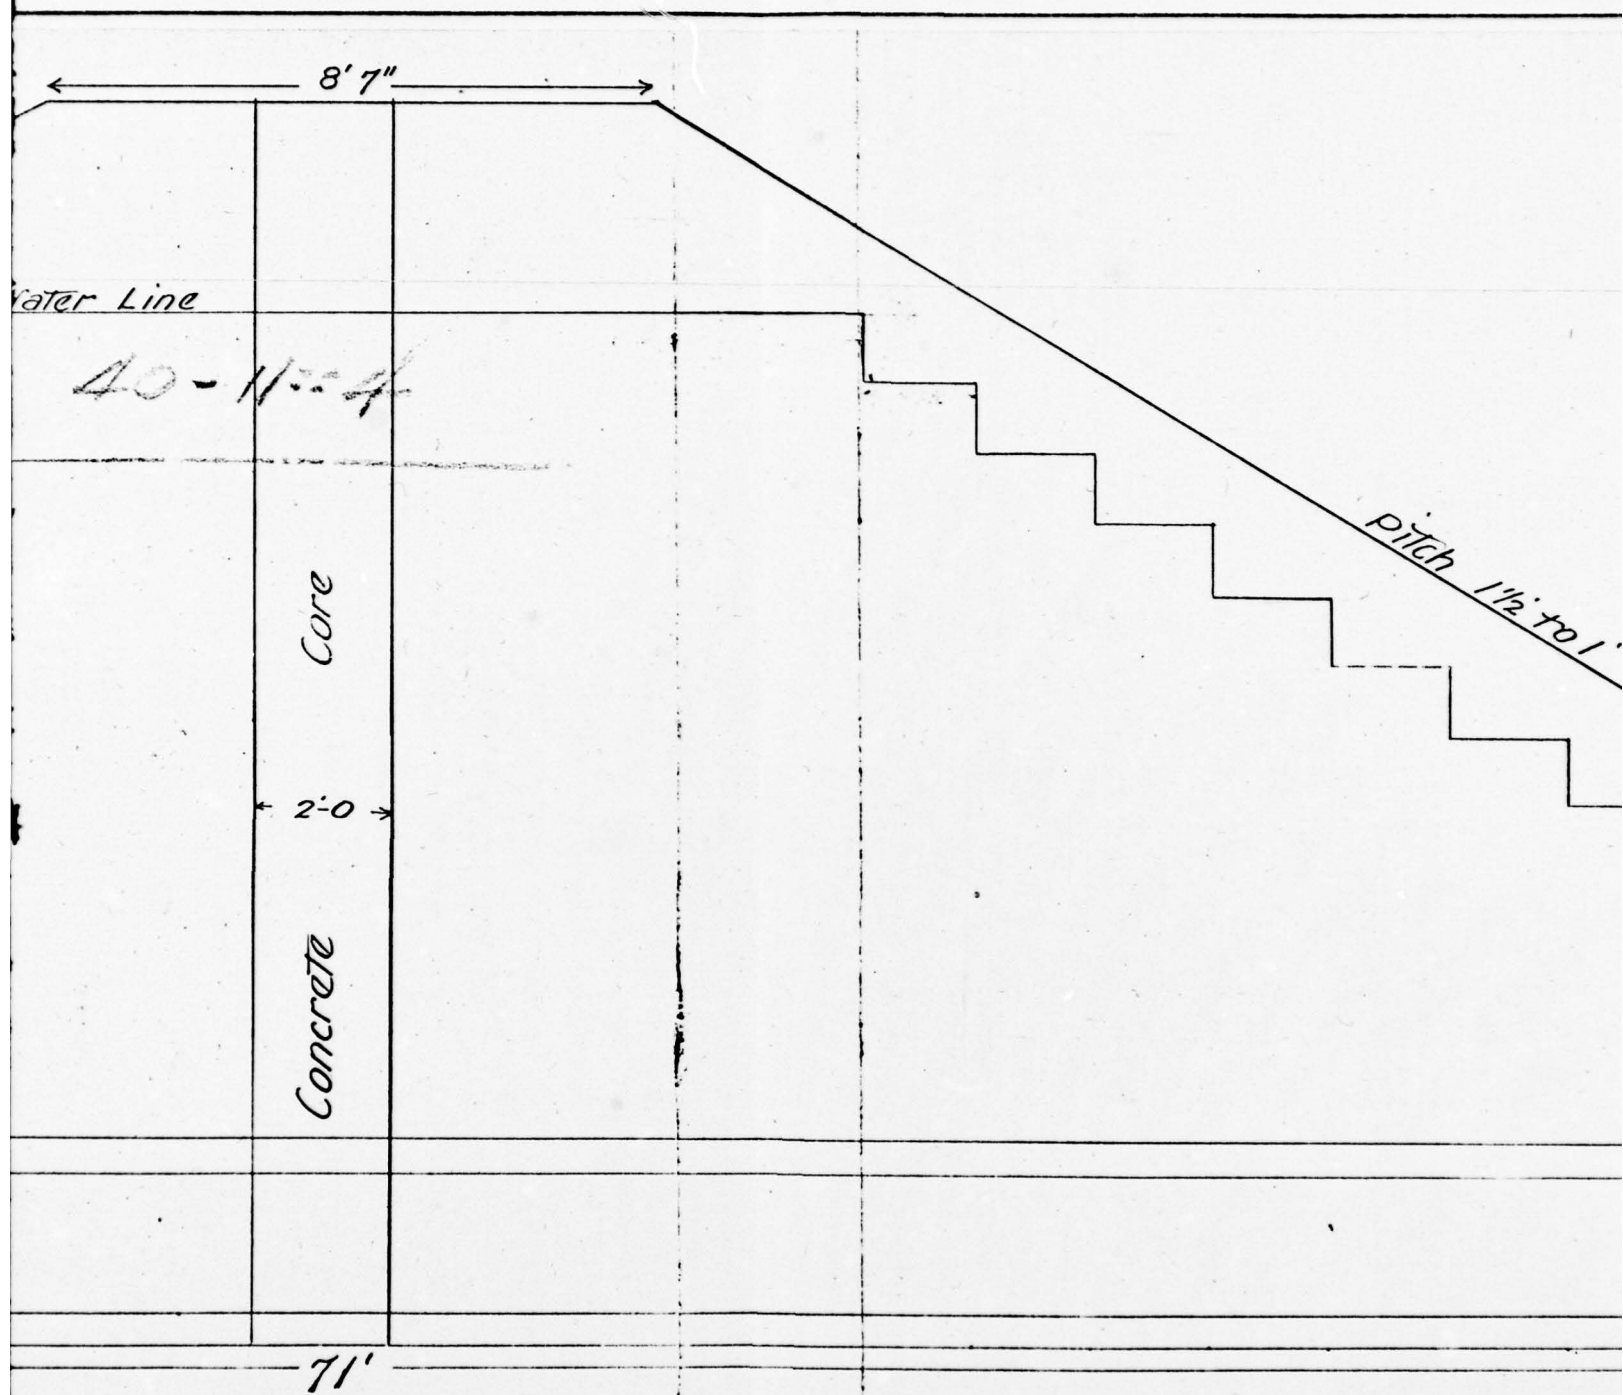
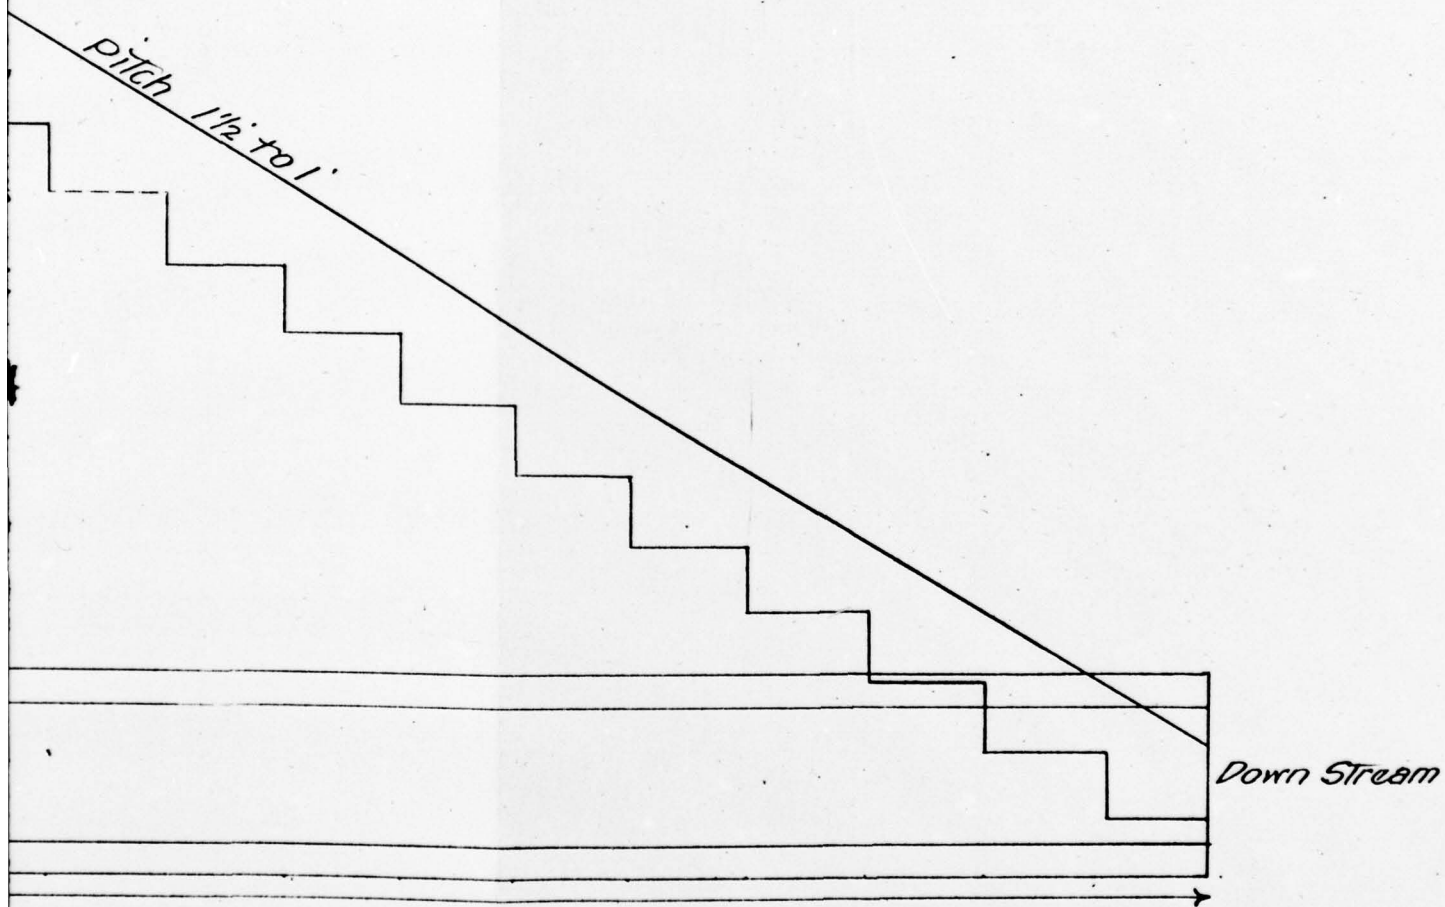
PLATE 2

b. Design Features. The project is described in Paragraph 1.2a. The various design features of the dam are shown on the Plates at the end of the Report. The existing features are shown on the Photographs in Appendix D. A plan and profile of the dam, as designed, are shown on Plate 2. During construction, the auxiliary spillway shown on this plate was lengthened to 200 feet. Also, 2 chutes have since been added across the top of the dam (Photograph D). A typical section of the dam as designed is shown on Plate 3. A profile of the spillway is shown on Plate 4.

ITEM	REMARKS
AS-BUILT DRAWINGS	SEE PLATES 2, 3, AND 4 "AS-BUILT" VARIES SIGNIFICANTLY FROM THE PLATES.
REGIONAL VICINITY MAP	SEE PLATE 1
CONSTRUCTION HISTORY	BUILT 1914
TYPICAL SECTIONS OF DAM	SEE "AS-BUILT" DRAWINGS.
OUTLETS: Plan Details Constraints Discharge Ratings	SEE PLATES 2 AND 3 NO RATINGS

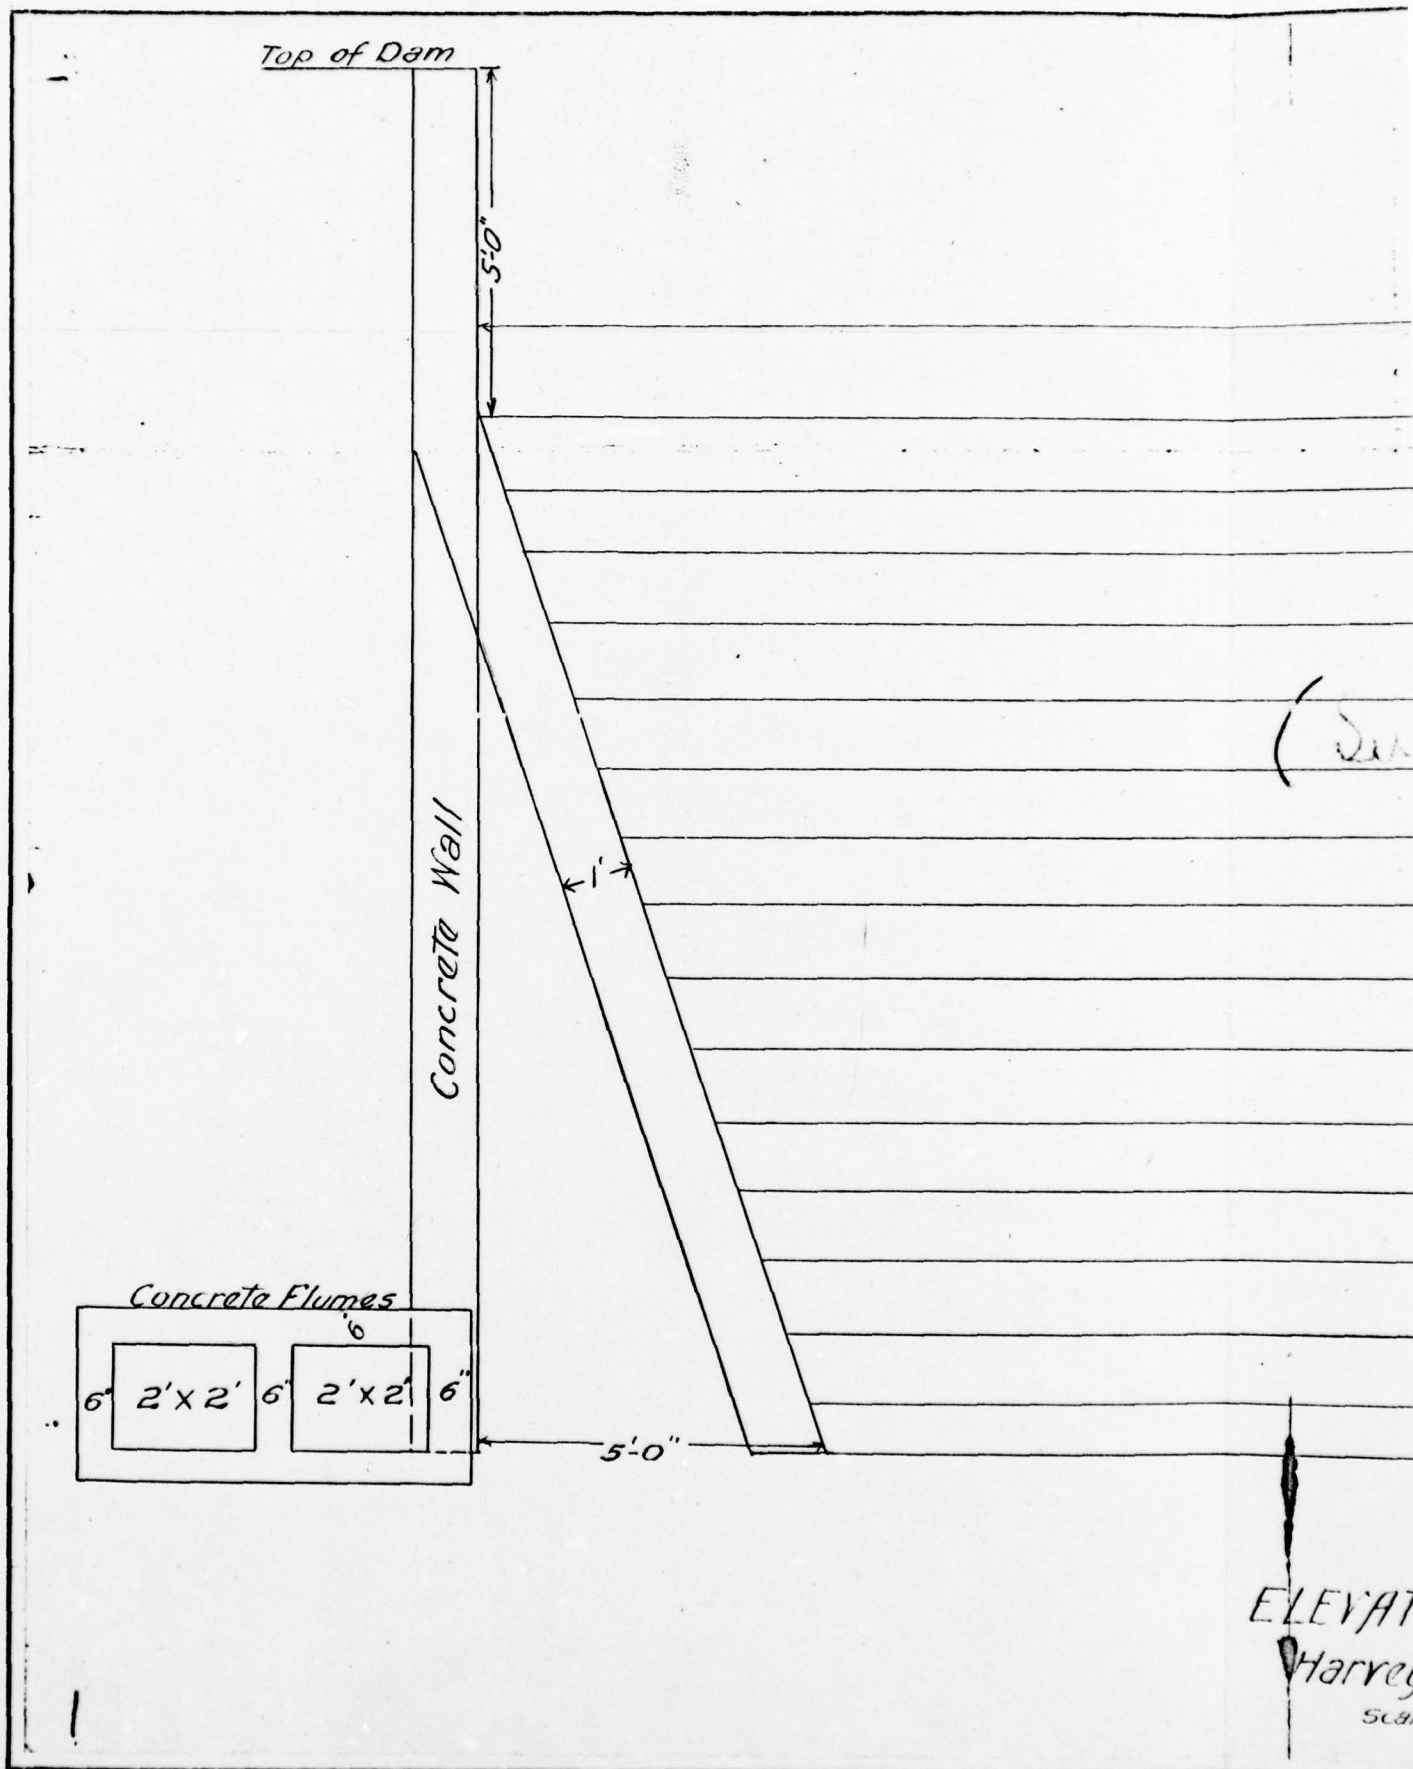
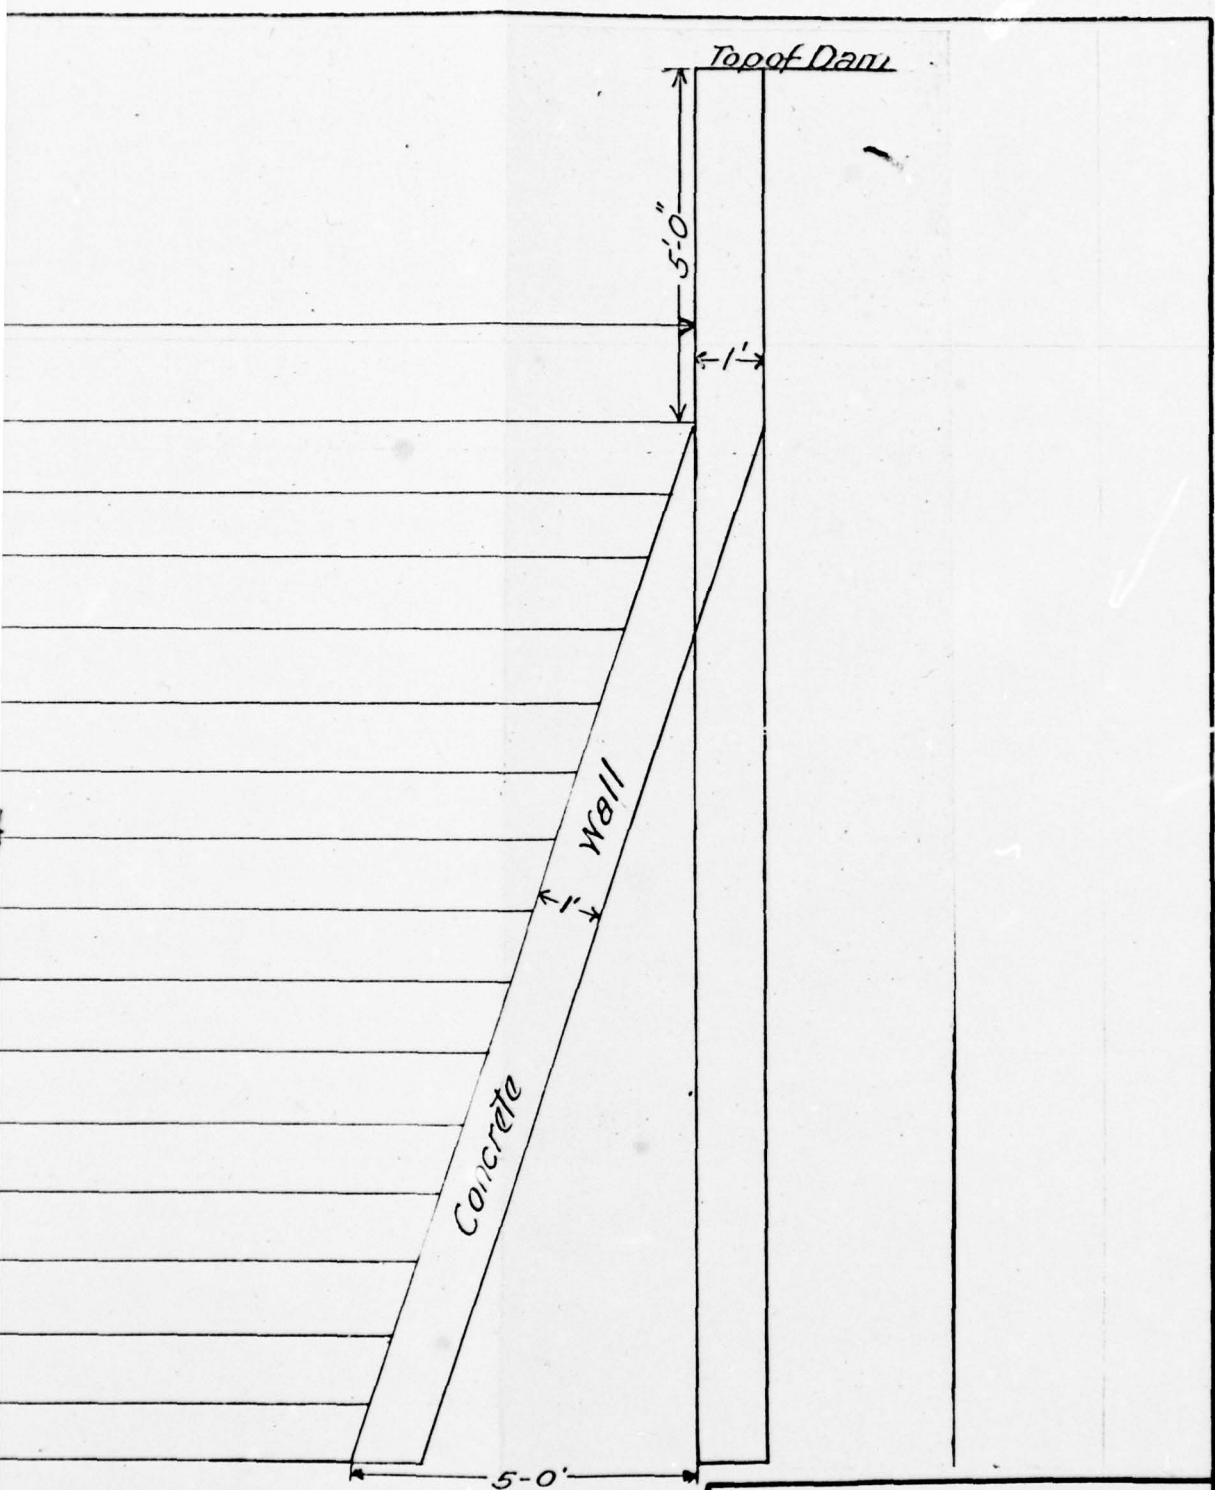
PLATE 3

c. Design Considerations. The core-wall is unreinforced and relatively thin. It is shown as being 2 feet thick on Plate 3. The 1914 Pennsylvania Water Supply Commission Report states that the trench in which the core-wall is founded is 4 to 6 feet deep. The trench caved in during construction and the trench was re-excavated and filled with concrete to a thickness of 3 to 4 feet. The core-wall was carried up for a height of 8 feet with a design thickness of 2 feet, at which point the wall was battered to a thickness of 1 foot at its top. It is not certain the wall was designed to carry the anticipated loads.

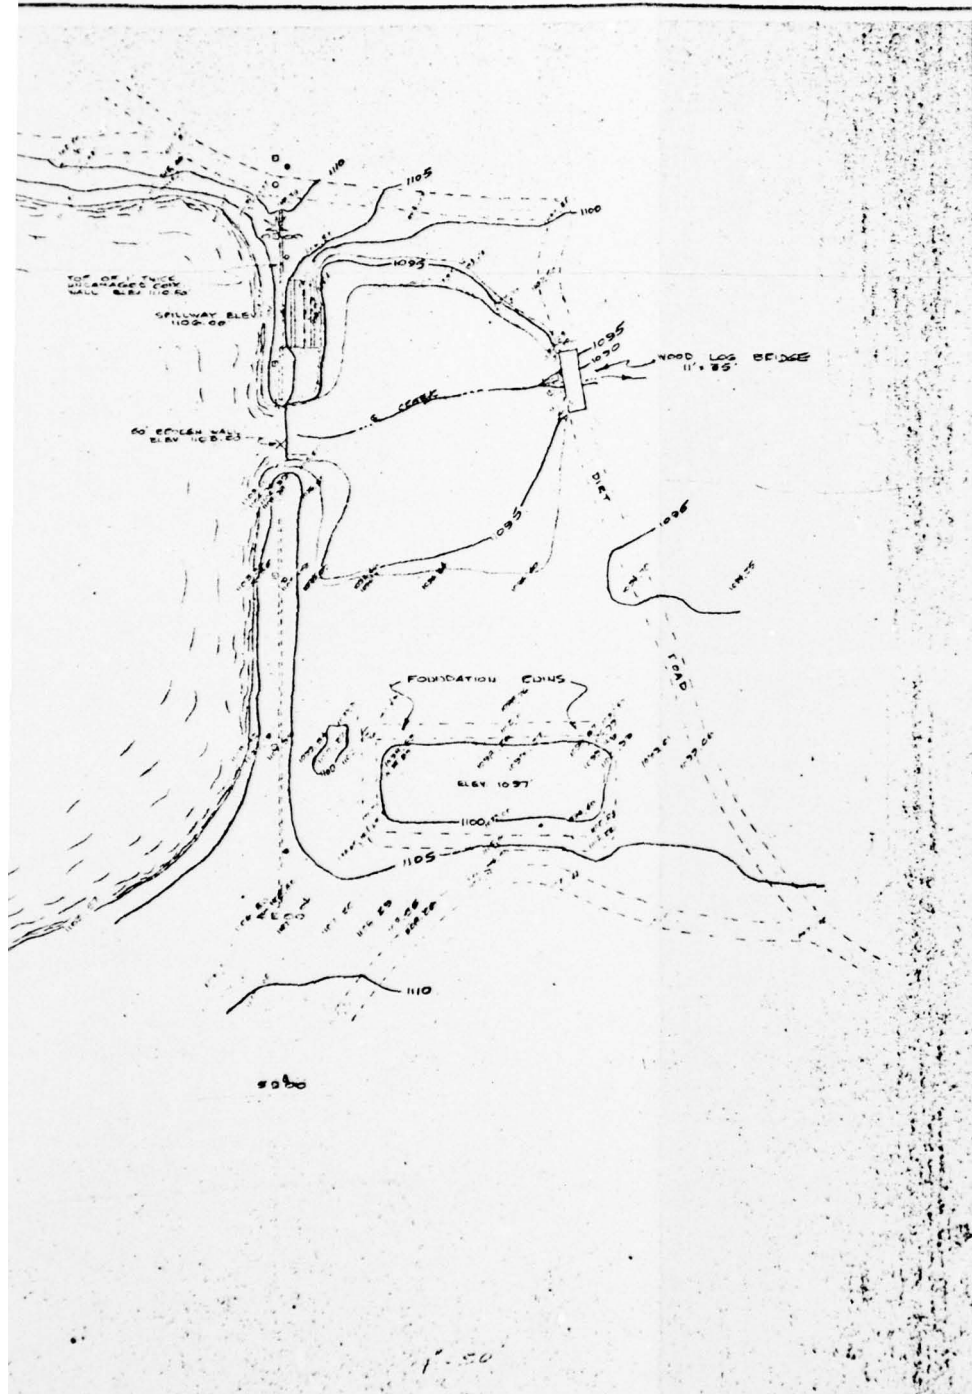
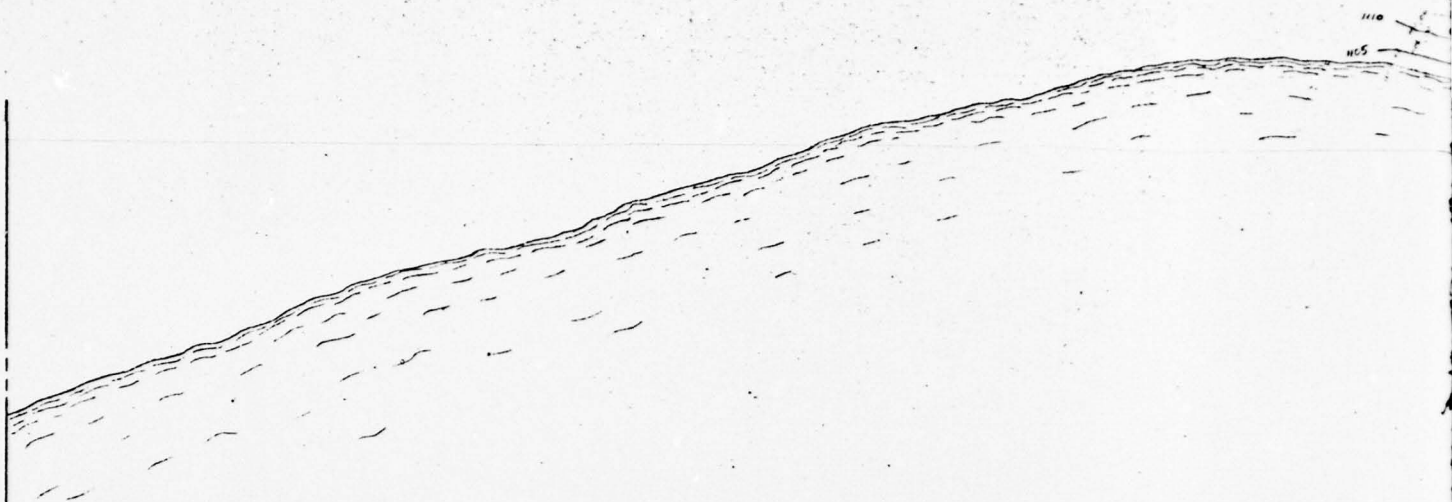
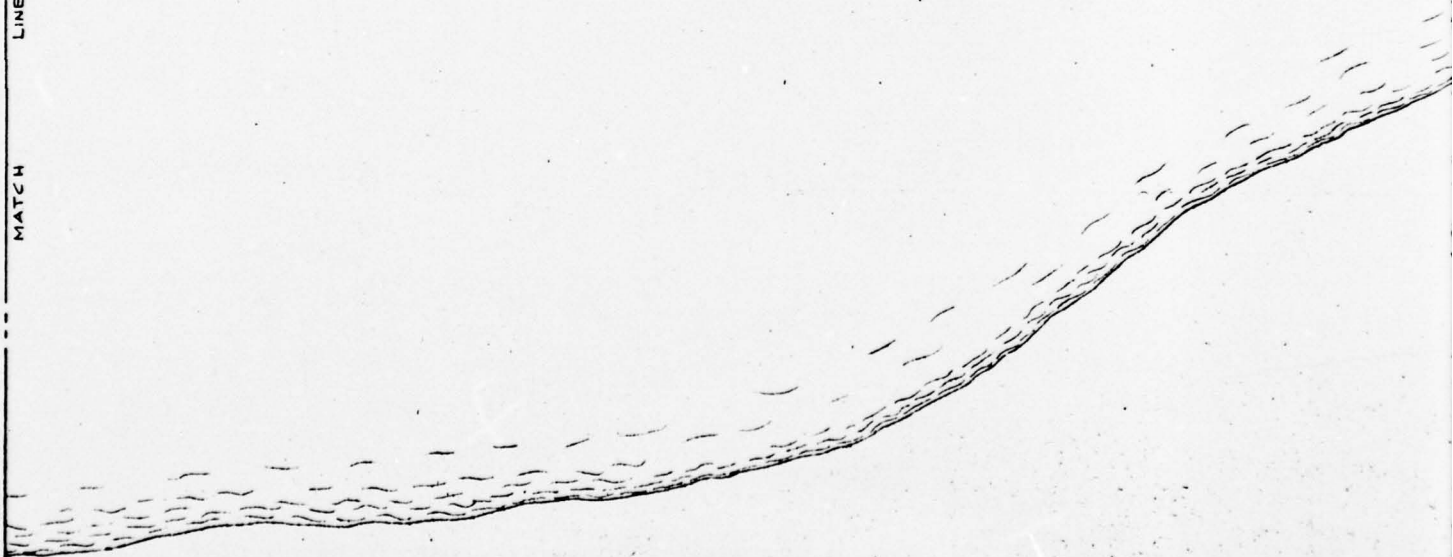
PHASE I INSPECTION REPORT NATIONAL DAM INSPECTION PROGRAM	
BRYANT POND DAM	
ESTATE OF GLENDORA BRYANT	
CONDITIONS IN JANUARY 1975	
JULY 1979	PLATE 5

The Owner reported that, two days prior to the peak flow from Tropical Storm Agnes in June 1972, a dam upstream failed, causing the overtopping of Bryant Pond Dam and the breaching of the embankment. The PFC terminated their lease shortly after this. Apparently, nothing immediately was done to repair the embankment. The Owner engaged an engineer to determine the feasibility of repairing the embankment. The engineer, Sweinberg and Kolesar Associates, of Forty Fort, surveyed the embankment in January 1975 (Plate 5).

ITEM	REMARKS
RAINFALL/RESERVOIR RECORDS	NONE
DESIGN REPORTS	1914 PENNSYLVANIA WATER Supply Commission Report
GEOLOGY REPORTS	NONE
DESIGN COMPUTATIONS: Hydrology and Hydraulics Dam Stability Seepage Studies	NONE - SOME DATA IN 1914 PENNSYLVANIA WATER Supply Commission Report
MATERIALS INVESTIGATIONS: Boring Records Laboratory Field	NONE
POSTCONSTRUCTION SURVEYS OF DAM	SEE PLATE 5 FOR CONDITIONS IN JANUARY 1975.
